Powerplus™ 100 Rocker Arm & Pushrod Clearancing

Clearancing the Front Exhaust Pushrod:

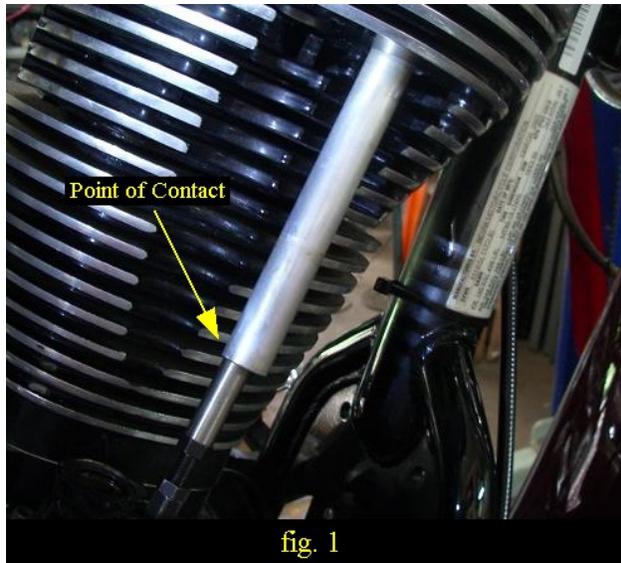
The larger size 7/16" front exhaust pushrod might rub at two places causing unnecessary noise and wear. At the lower end of the upper pushrod tube (fig.1) and where it passes through the lower half of the rocker box (fig.2).

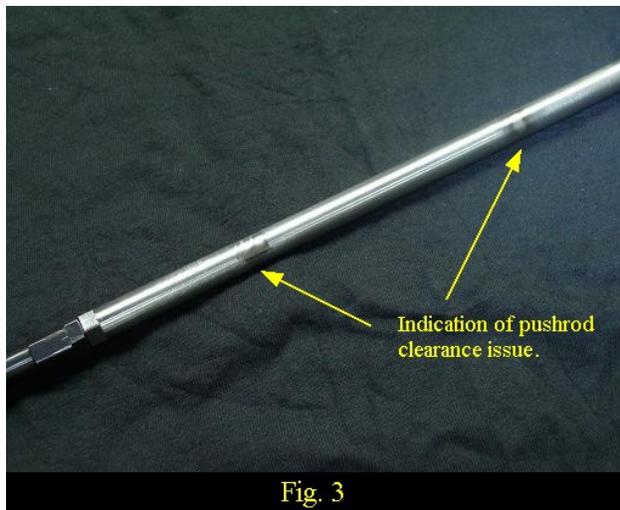
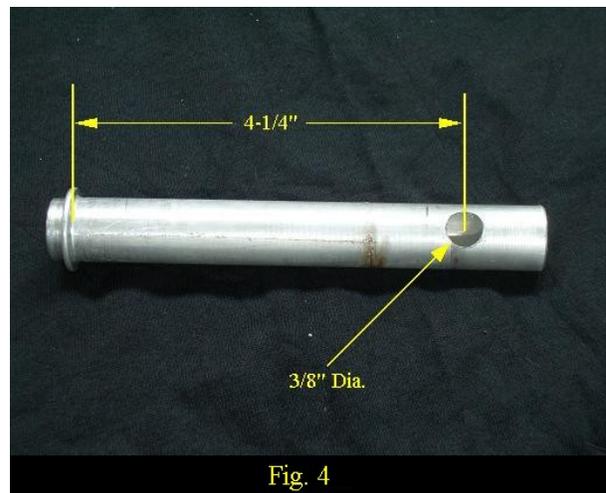
An indication that there is a clearance issue can clearly be seen by wear marks on either end of the pushrod itself (fig.3).

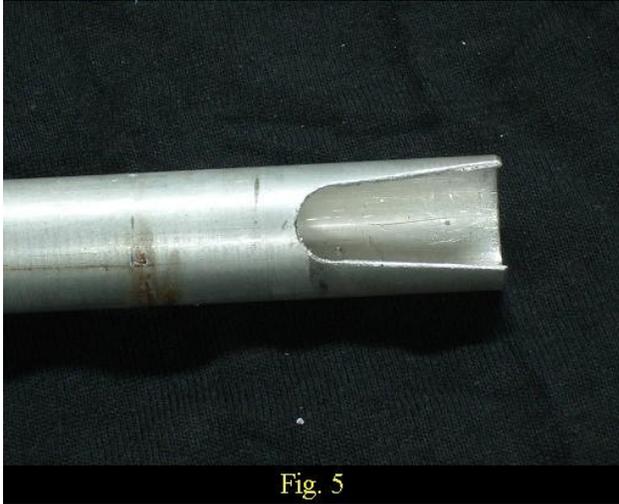
To clearance the upper pushrod tube, start by drilling a 3/8" dia. hole 4-1/4" from the ridge at the top of the tube (fig.4). Then cut a wedge shape from the drill hole to the bottom edge (fig.5).

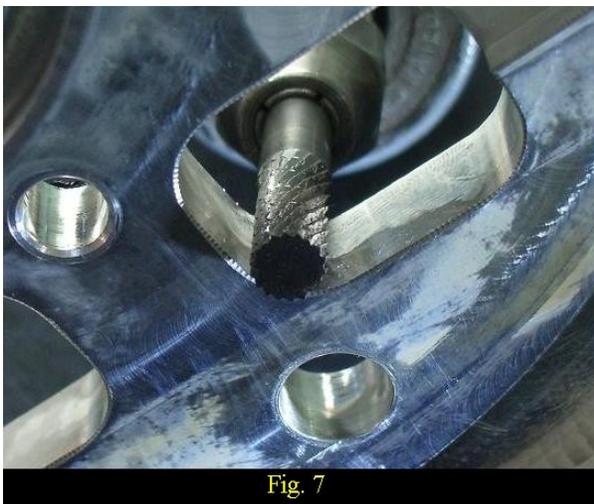
Fig. 7

To clearance the lower half of the rocker box, remove a small amount of material in the right rear corner of the passage along the same plain as the pushrod (fig.7 & 8).

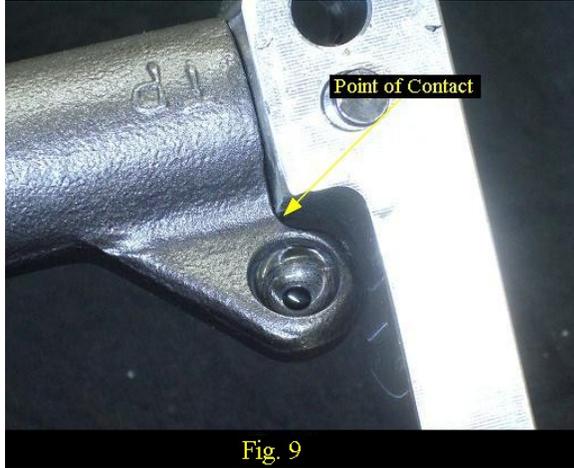
In some cases roller rocker arms may contact the rocker arm girdles causing noise and limiting rocker arm travel. This can be found on the small radius where the pushrod receiver arm meets the rocker arm body (fig.9) and at the opposite end along the edge of the valve arm (fig.10).

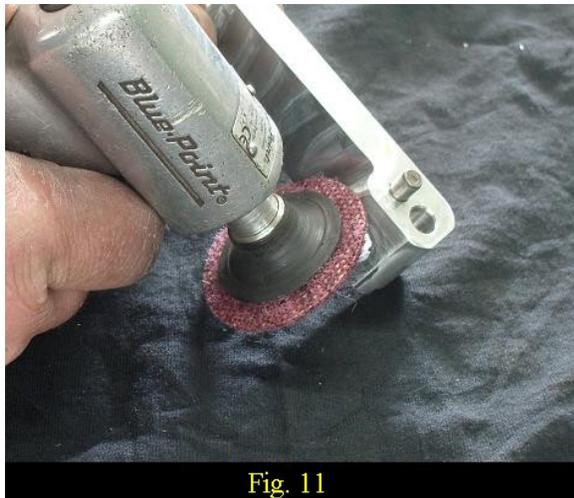
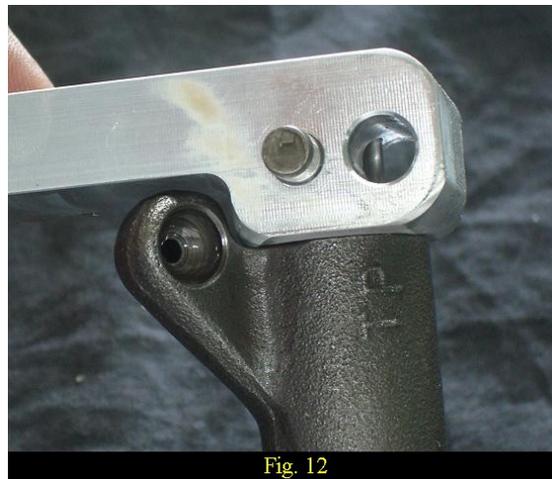
This condition can easily be remedied by removing material on the girdle at each contact point with a 3M™ disc on a pneumatic surfacing tool (fig. 11 & 12).

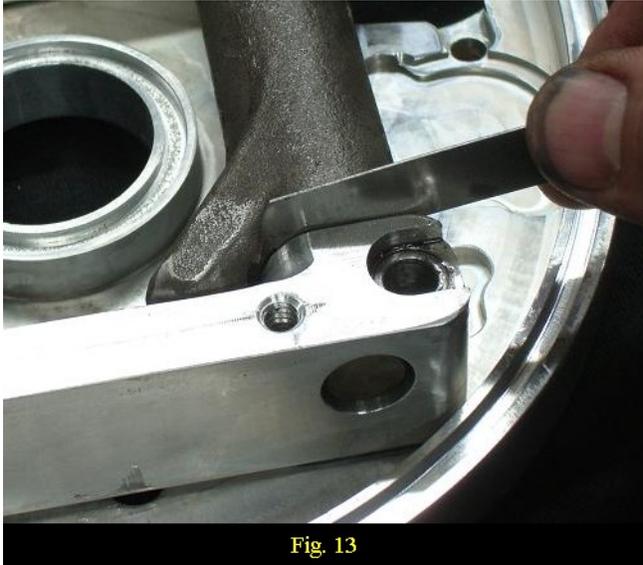
Fig. 13

Another cause of excessive noise is the side to side motion of the rocker arms. Placing a shovelhead style shim on the pushrod side between the rocker arm and rocker arm girdle will eliminate this. Before unbolting the rocker arm girdle from the cylinder head measure the space between the rocker arm and girdle with a feeler gauge (fig.13). Use a combination of shims that will bring the clearance between .003”-.005”. Typically, shovelhead rocker arm shims come in .005”, .007”, .010”, .015”, .020” and .025” thicknesses.
